SLOAN REGAL

COMPETITIVE STYLE

TROUBLESHOOTING AND MAINTAINING THE REGAL FLUSH VALVE

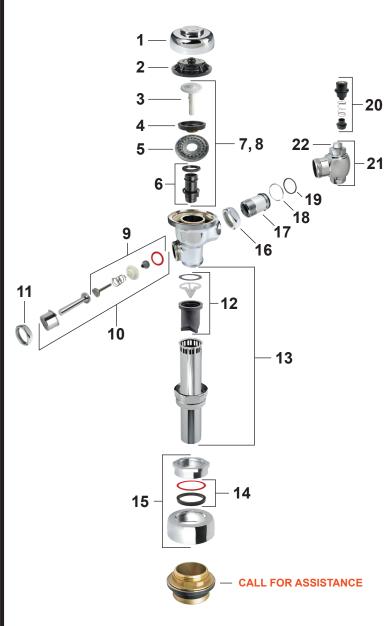
1	#08083	R10	C.P. Cover
2	#08050	A71	Inside Cover
	#08004	A19AC	Closet R. Valve(White)
	#08005	A19AU	Urinal R. Valve(Black)
3	#08345	A19ALC CI	oset/Urinal R. Valve(Green)
4	#08003	A15A	Molded Disc
5	#08002	A156A	Diaphragm
ADJUSTABLE GUIDES

#08006	A163A	Standard Guide
_	#08252	A152A	For 3.5 GPF Closet
6	#08348	A151A	For 1.6 GPF Closet
	#08349	A155A	For 1.0 GPF Urinal
7	#08000	A38A	3.5 Closet Water Saver Kit
′	#08114	A41A 1	1.6 Closet Low Consumption
0	#08001	A37A	Urinal Retro Kit - 1.5 GPF
8	#08115	A42A	Urinal Retro Kit - 1.0 GPF
9	#08007	B50A	Handle Repair Kit (Plastic)
40	#08008	B32A	C.P. Handle Assy.
10	#08069	B73A	A.D.A. Handle Assy.
11	#08054	A6	C.P. Handle Nut
12	#08012	V551A	V/B Repair Kit
CHROME PLATED VACUUM BREAKERS

#08014	V500AA	1-1/2" x 9" Closet
13	#08015	V500AA	1-1/4" x 9" Urinal
	#08016	V500AA	3/4" x 9" Urinal
	#08020		1-1/2" Gasket Kit
14	#08021		1-1/4" Gasket Kit

#08022		3/4" Gasket Kit
	#08142	F56A	1-1/2" Coupling Assy
15	#08143	F55A	1-1/4" Coupling Assy
	#08144	F54A	3/4" Coupling Assy
16	#08040	H550	Tailpiece Coupling Nut
17	#08039	H551A	Adj. Tailpiece 2-1/16" (Other Lengths Available)
18	#08038	H552	Locking Ring
19	#08037	H553	"O" Ring
20	#08033	H5/3/2D	3//" Control Ston Panair Vit
20	#08032	H541ASD	3/4" Control Stop Repair Kit Control Stop Repair Kit For 3/4" or 1"

#08471	H790A	1" Screwdriver Stop
21	#08469	H790A	3/4" Screwdriver Stop
22	#80793	H1012A	C. P. Cover
